SEWER SYSTEM EVALUATION STUDY GWYNNNS FALLS SEWERSHED STUDY AND PLAN

4.0 Sewer System Evaluation Study

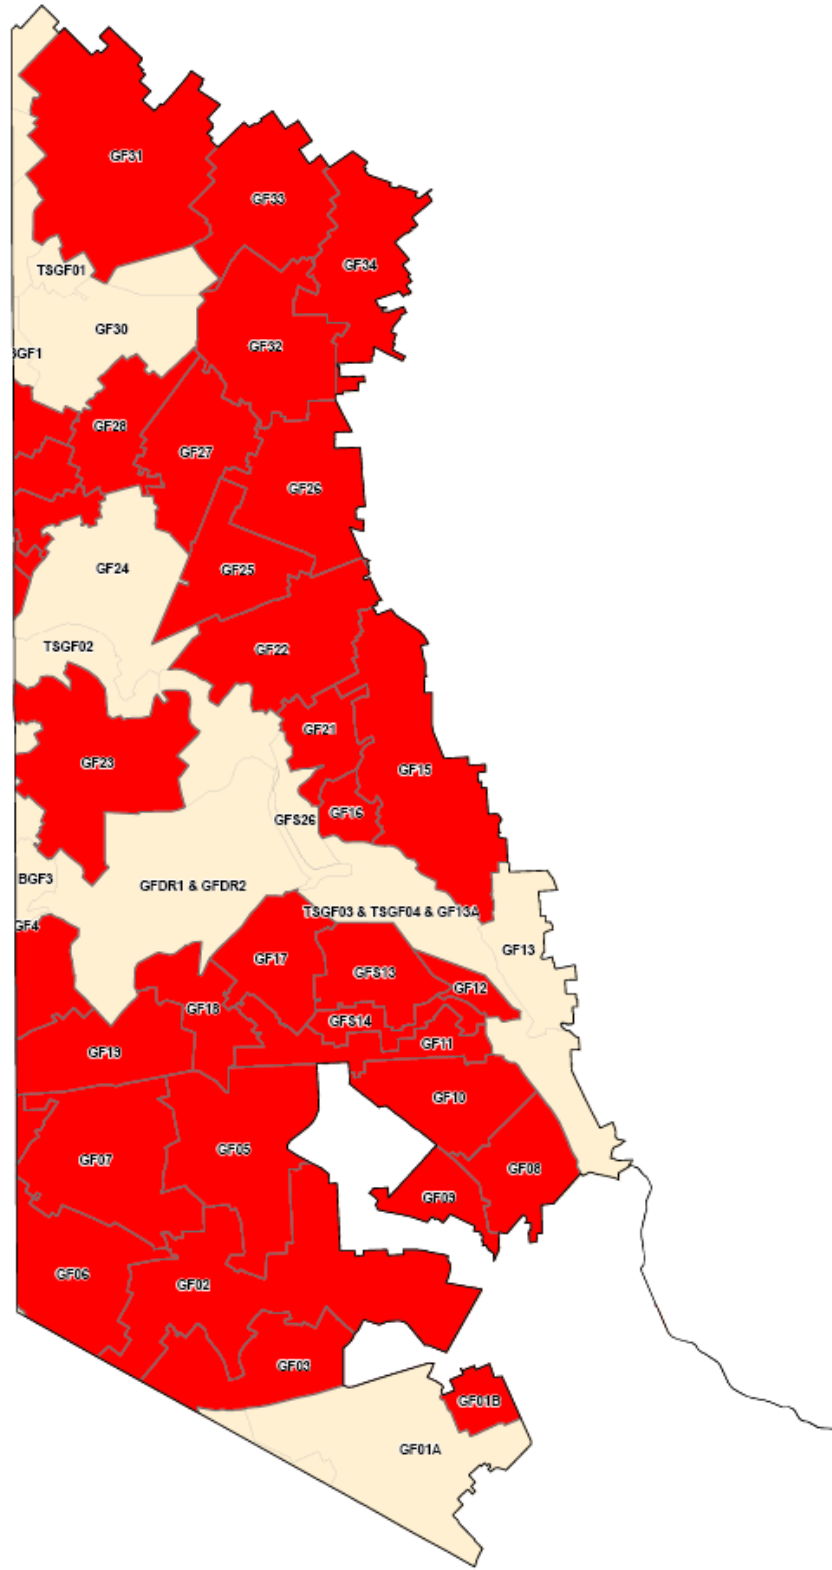
Figure 4.4.1 – Smoke Test Locations

Suspect inflow or RDII sources such as driveway drains, stairwell drains, window well drains, patio and area drains, downspouts piped underground, and foundation drains were noted. Significant potential sources of “clear water” connections (such as storm drain or catch basin connections) were noted and were recommended for follow-up dyed-water testing to determine if actual cross connections existed. Care was taken to inspect the property around all buildings for sources of smoke.

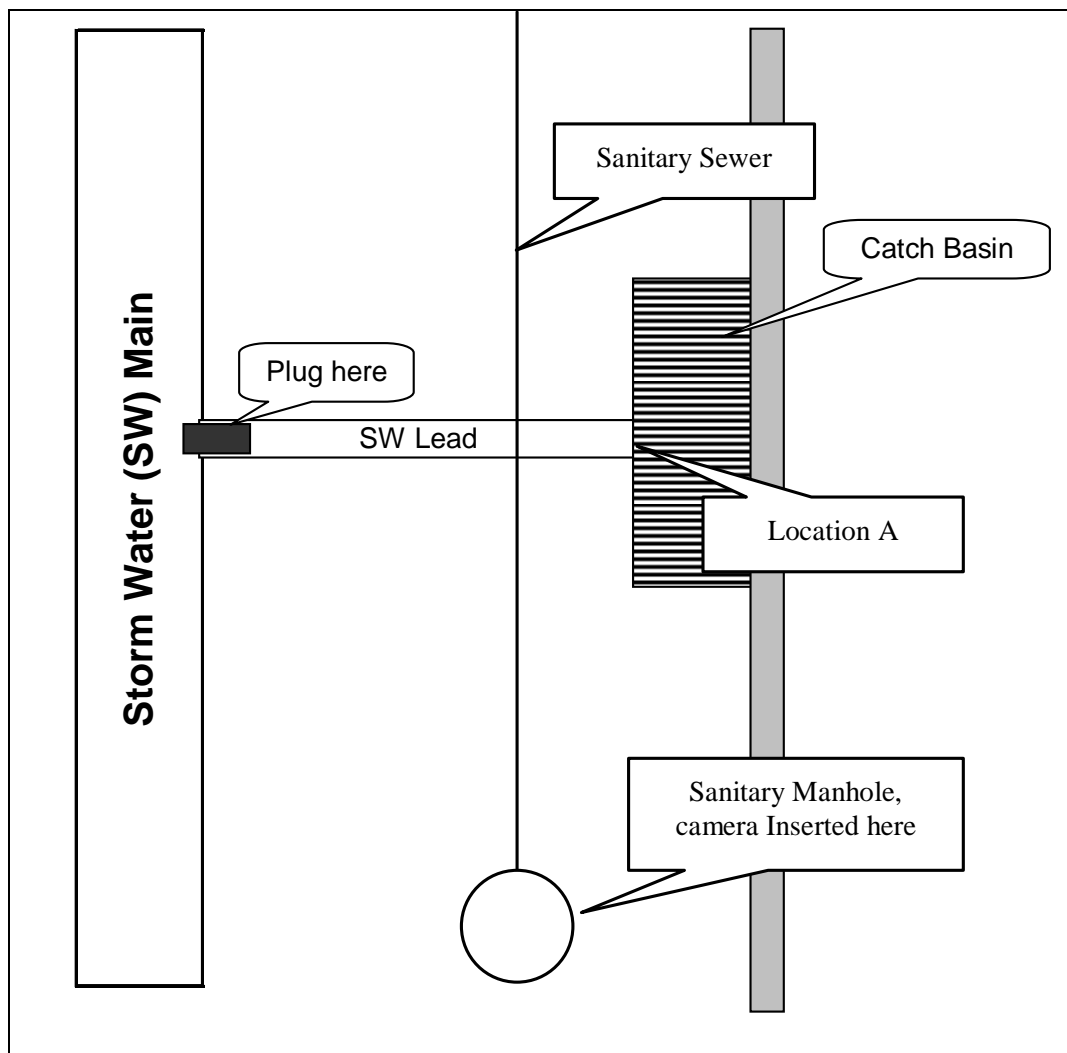
Figure 4.5.1 – Dye Flood Configuration

Dyed-water flood tests were performed at stormwater inlets located in the public right of way where direct connections to the wastewater collection system were suspected to exist. As shown in Figure 4.5.1, dye flood tests were performed by plugging the suspected storm drain and partially filling it with dyed water. A CCTV camera inspected the sanitary sewer, observing and locating defects that permit stormwater and/or sources of infiltration into the sanitary sewer. A dyed-water flood test was determined to be positive if the existence of a direct connection was established or if dyed water was observed in the sewer main as a result of trench migration from the storm main and infiltration through joints or defects.

A minimum of six inches of standing water (as measured from Location A in Figure 4.5.1) was required to complete each test. This hydraulic condition was maintained for a minimum of 15 minutes. If dyed water was not detected in the sewer after 15 minutes, the test was abandoned and the negative test result was noted in the dye flood database.

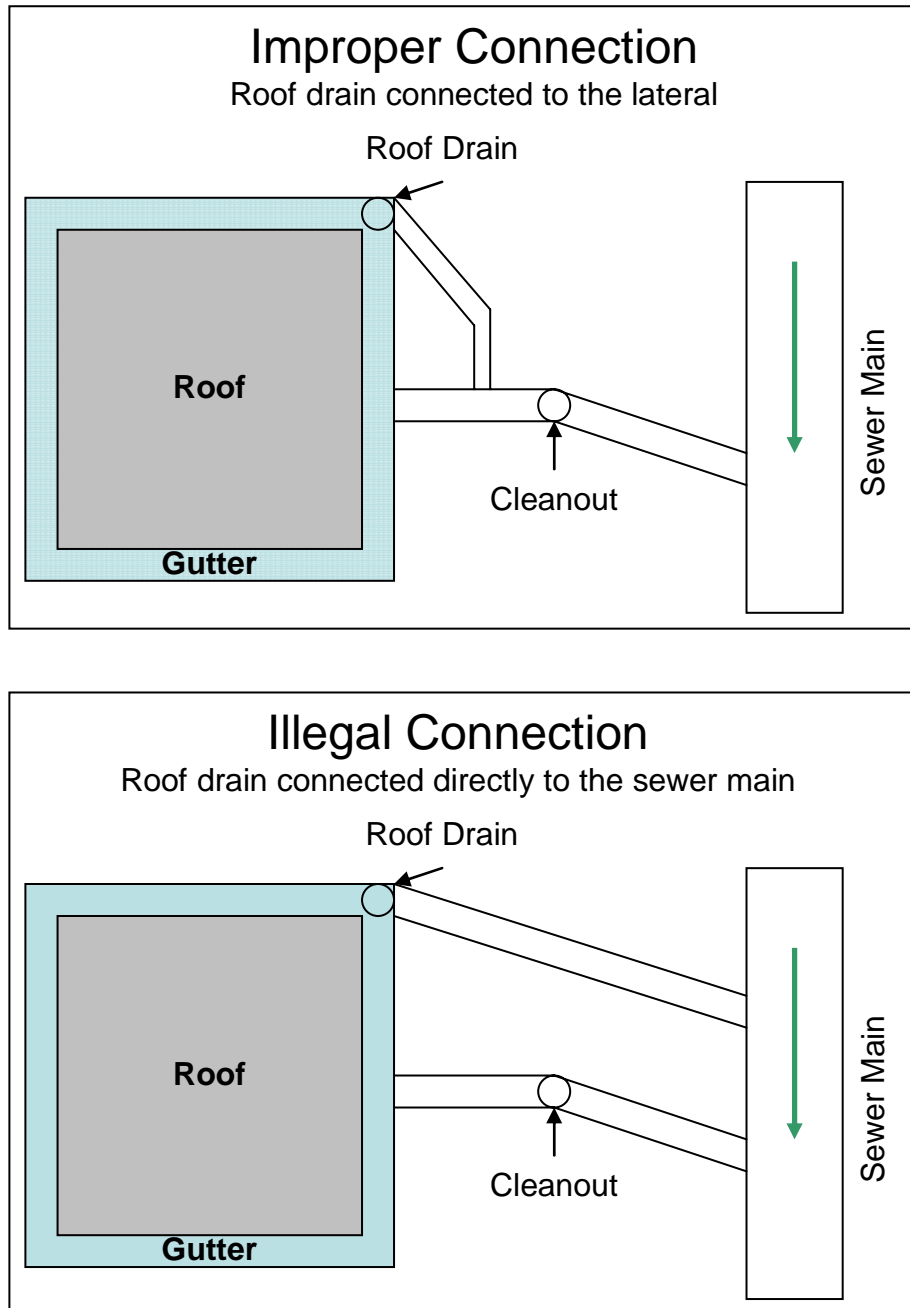
Figure 4.5.2 – Downspout Test Configuration

tests were performed in order to determine whether each downspout connection was illegal or improper, as illustrated by Figure 4.5.2. Dye roof tests were performed by inserting green dye at the cleanout location and red dye at the roof drain, or downspout, location. A CCTV camera inspected the sanitary sewer, observing and locating the point of entry of both dye colors into the sanitary sewer system.

Dye tests confirmed that there were no locations where the stormwater system was directly connected to the wastewater collection system. In general, none of the 122 dye flood tests performed at catch basins confirmed a direct connection to the wastewater collection system. However, 66 of the tests confirmed stormwater exfiltration from the storm drain entering the sanitary sewer as infiltration through various sewer defects such as cracked/broken house laterals and sewer main fractures/holes, and under manhole frame and covers. As a result of the downspout tests, 3 illegal and 76 improper connections were identified.
